MISSISSIPPI DELTA PIPELINE SURVIVAL STRATEGIES

James R. Hooper

Fugro-McClelland Marine Geosciences

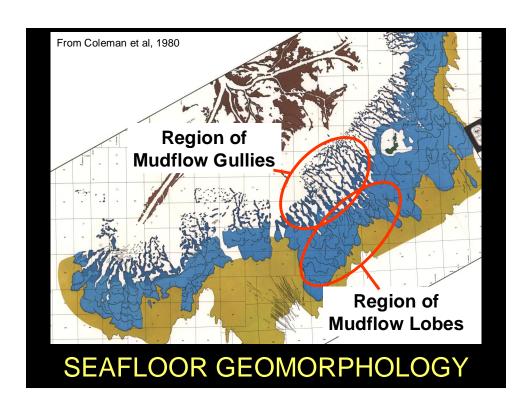
CHARACTERISTICS OF SEAFLOOR FAILURE FEATURES (cont.)

Mudflow lobes tend to be geologically active, but not (generally) as active as the gullies. Down slope mudslide movements destructive to pipelines may occur only every few years.

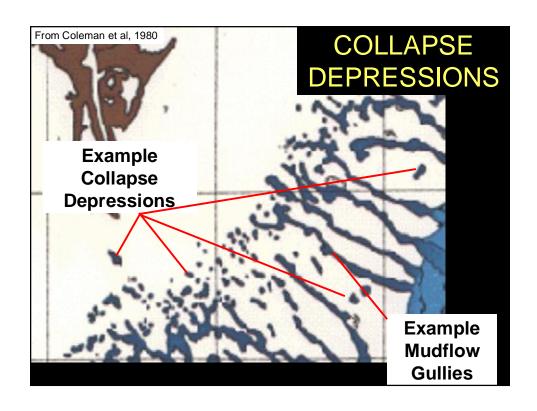
CHARACTERISTICS OF SEAFLOOR FAILURE FEATURES (cont.)

- Collapse depressions are locally enclosed seafloor failures that are generally bounded by low scarps.
- They tend to be as geologically active as mudflow gullies.
- Active depths of failure range from 10-20 ft to 40-60 ft.

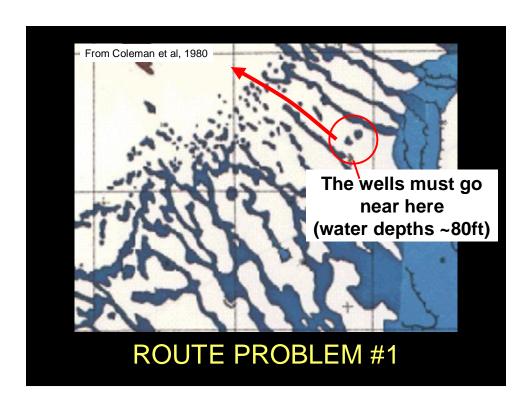
ROUTE 1 RISKS

- The pipeline may have to cross one or more collapse depressions.
- Seafloor lateral movements and/or loss of bearing support may cause periodic failures.
- Over a period of years, new collapse depressions may appear.

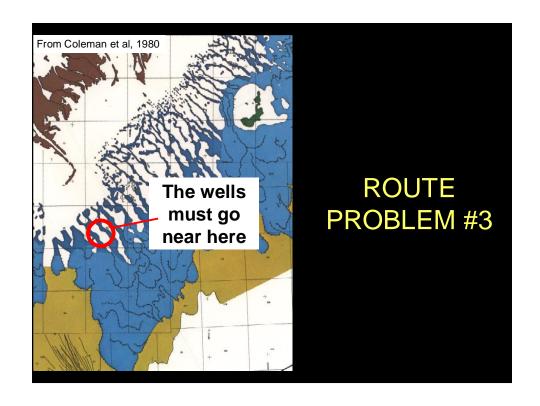
ROUTE 2 RISKS

- The pipeline must cross a mudflow gully plus several collapse features.
- Seafloor lateral movements in the gully and/or loss of bearing support in collapse depressions may cause periodic failures.
- Failure activity region may enlarge, depending on future hurricane wave activity.

- Failures may be "fixable" over time, by local rerouting during pipeline repairs.
- On the other hand, conditions may get worse, and the pipeline may become an economic burden.

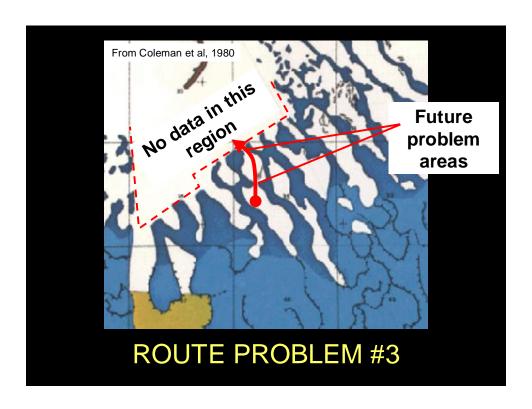
ROUTE 3 RISKS

- The pipeline must enter unmapped territory that is very likely to contain several mudflow gullies and numerous collapse depressions.
- The narrow "safe seafloor" regions along the route may be cut by growing mudflow gullies, creating major problem areas.
